MARINE GAS TURBINE HOT CORROSION
DEPENDENCE ON INGESTED SALT LEVELS

Report No. FR-11544

R.H. Barkalow and F.S. Pettit
United Technologies Corporation
Pratt & Whitney Aircraft Group
Government Products Division
West Palm Beach, FL 33402

16 April 1979

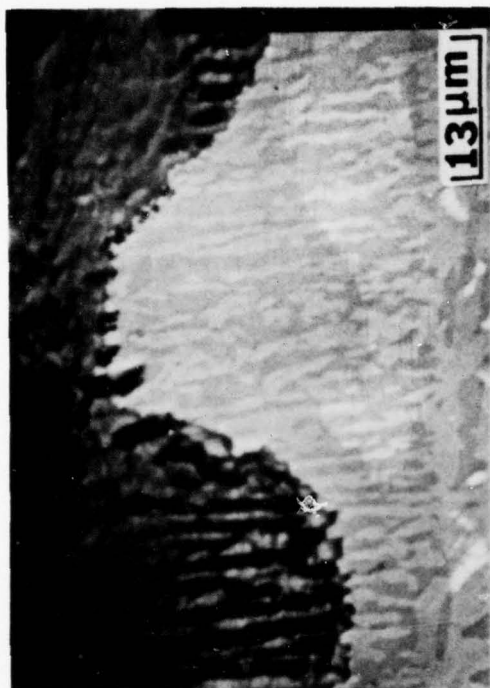
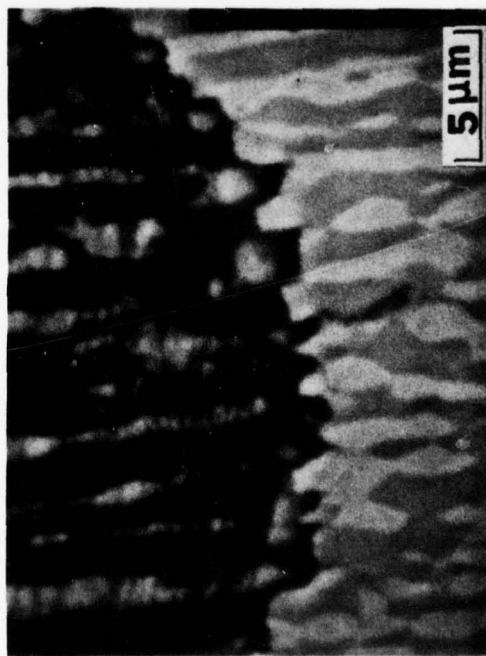
15a. Nodular attack and surface scale

15b. Ghost microstructure of oxidized coating

15c. Attack front at bottom of nodule

Figure 15. SEM photomicrographs (back scattered electrons) and X-ray maps (approximately the area of 15b) showing the structure and composition of the scale and scale/metal interface after 704C hot corrosion of PWA 68 CoCrAlY at $PSO_3 = 0.004$ atm. Figs. b and c show areas in 15a at higher magnification.

**Wet polished specimens have sometimes shown a generally broad distribution of sulfur (but not sodium) rather than the concentration of sulfur at the attack front as illustrated in Figure 15. Conversely it has been observed that dry polished specimens sometimes show a well defined sulfur-rich band at the attack front rather than the uniform distribution of sulfur shown in Figures 16 and 17. Easily detectable sulfur is invariably present, however, and the sulfur-containing scale is a characteristic feature with important implications regarding the mechanism of SO_3 -induced attack, even though the sulfur distribution (i.e. uniformly in the volume of the protrusion or concentrated at the attack front) may be variable and not well understood.

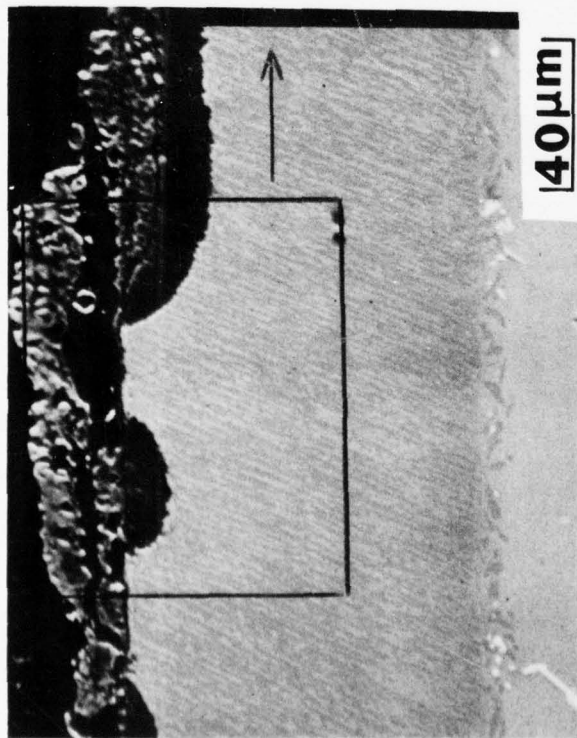
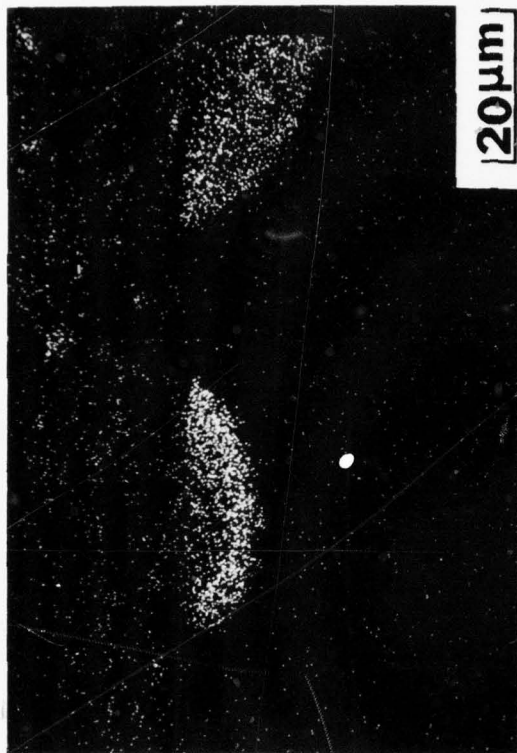
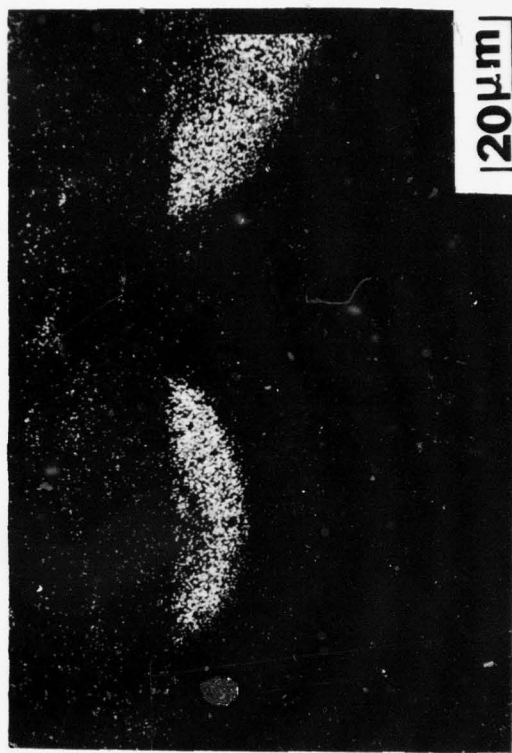
Typical scale thickness and depth of attack

Sodium X-rays

Sulfur X-rays

Figure 16. Accumulation of Na_2SO_4 salt in developing protrusion, as shown by sodium and sulfur X-ray images of a dry polished specimen. Depth of attack illustrated was produced by exposure for 40 hours at 704C with $p\text{SO}_3 = 0.0007$ atm. Area at right of box is shown at higher magnification in Fig. 17

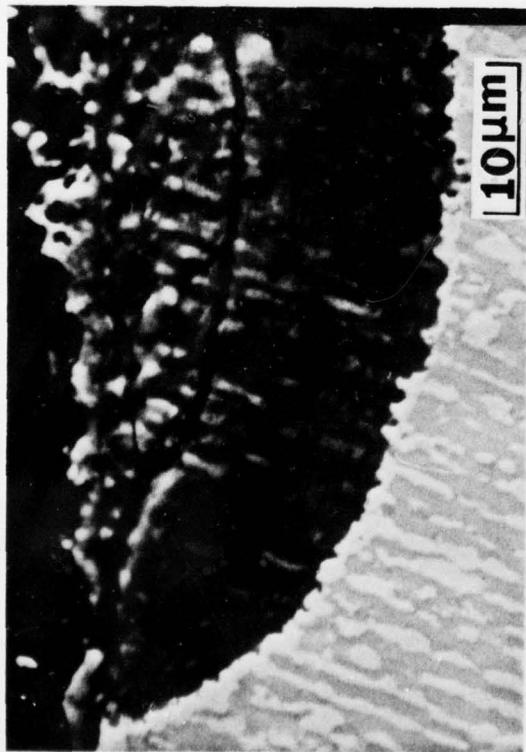
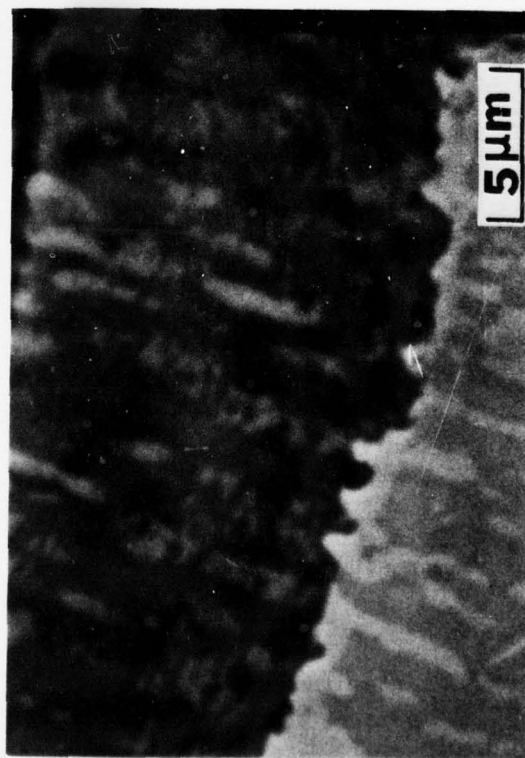
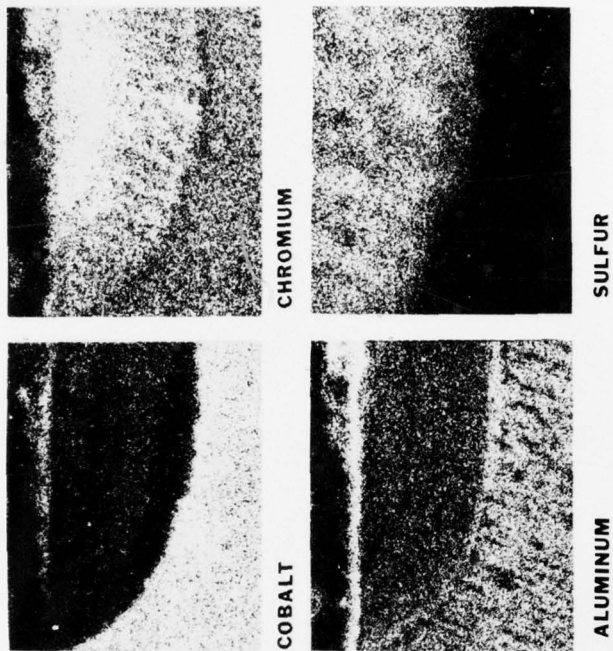
Back scattered electron photomicrographs

Figure 17. High magnification SEM photomicrographs of a portion of the developing protrusion illustrated in Fig. 16. Note the ghost image in the oxidized coating, including resolution of the columnar microstructure in the Cr X-ray map. Also evident are the fine striations parallel to the scale/metal interface and a very thin β -denuded zone at the corrosion front.

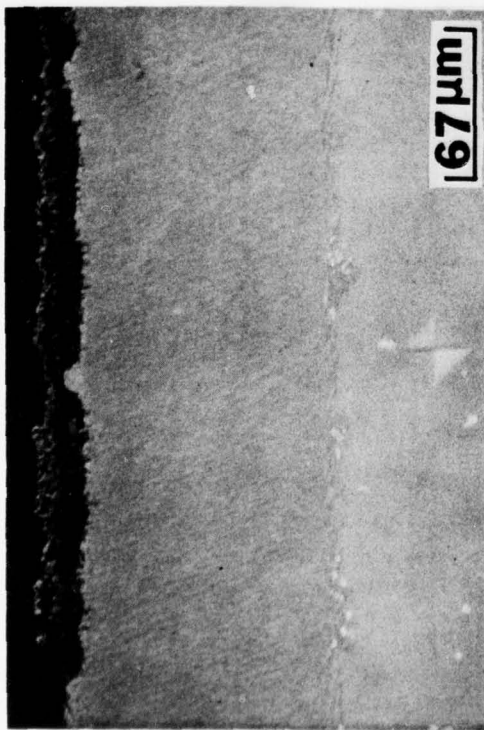
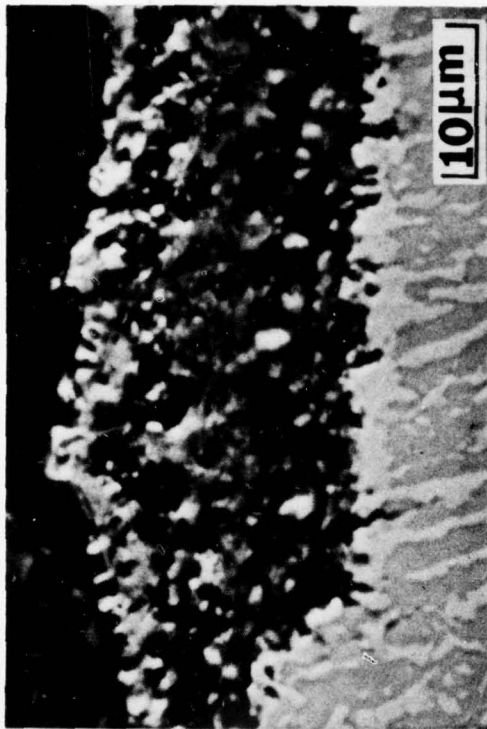
Typical depth of attack and scale thickness

Microstructure of attack front

Figure 18. SEM photomicrographs (back scattered electrons) and X-ray maps showing the structure and composition of the scale and scale/metal interface after 100 hours at 704C and $p_{SO_2} = 0.0001$ atm. Note the characteristic Co depletion and Co-rich cap, the presence of Al and Cr in both the pit and the external scale, and the presence of sulfur in the scale at the corrosion front.

It is clear that SO_3 -induced hot corrosion of CoCrAlY is less severe at 899 than at 704°C. Although 100-hour exposure at 899°C and $p_{\text{SO}_3} = 0.0007$ atm produced substantial microstructural degradation in some areas (e.g. Figure 22), examination of the test coupons after 20 hours showed extensive corrosion at 704°C versus negligible attack at 899°C, and weight changes were much less at the higher temperature (Figure 28). At 0.0001 atm, the negligible 899°C attack indicated by surface condition (Figure 20c) and post-test metallography contrasts with the significant extent of corrosion shown in Figures 13 and 18.

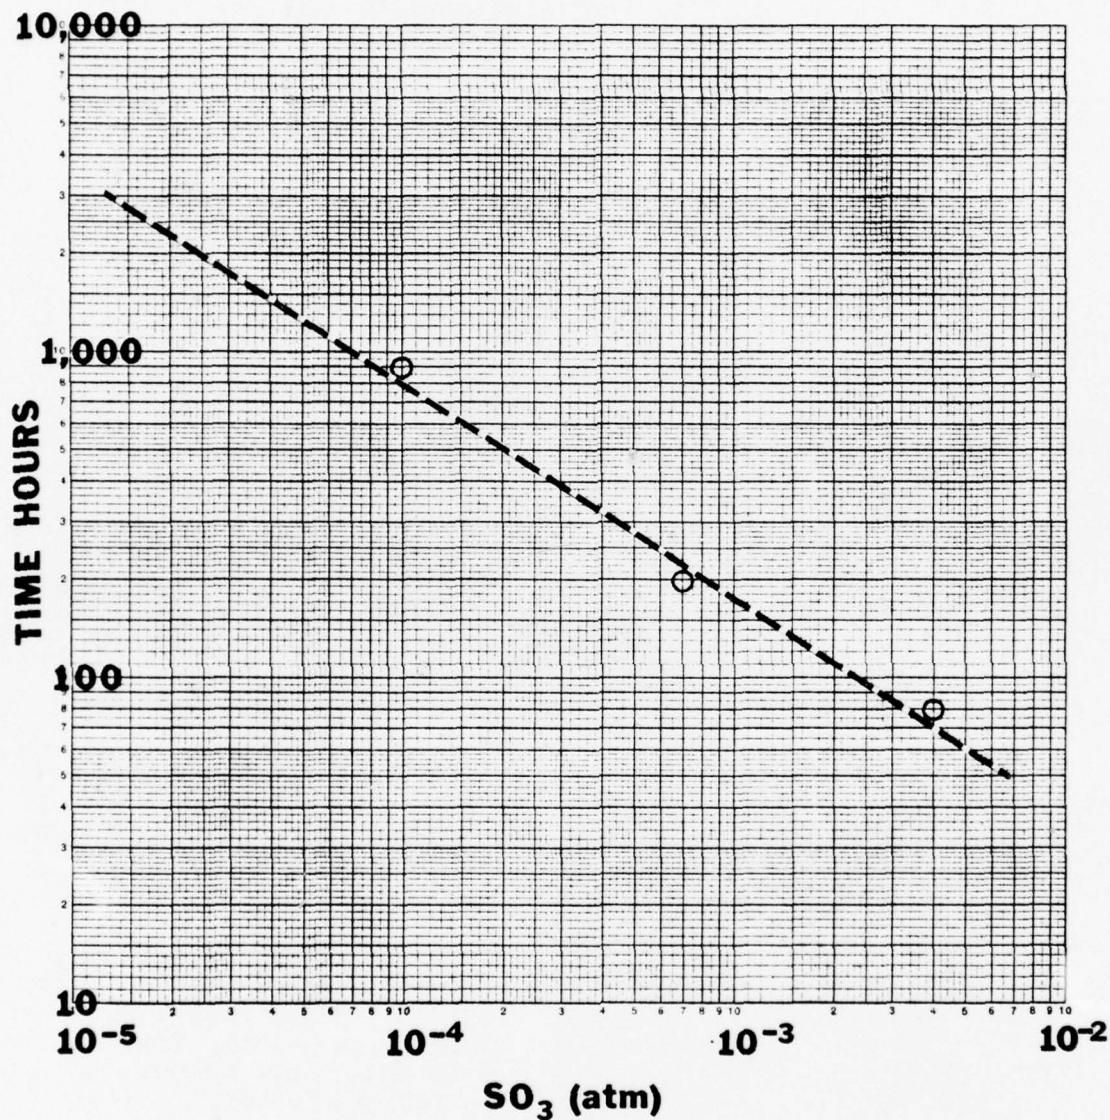
Figure 19. Time to penetration versus SO_3 pressure for PWA 68 CoCrAlY coating tested as described in text. Note that the graph is an approximation serving only to demonstrate a dependence of rate of attack on SO_3 pressure under otherwise constant test conditions. It is not a prediction of service lifetime versus SO_3 pressure in a gas turbine engine.

Although the graph of Figure 19 must be interpreted with caution because of the limited testing and crude approximation of failure times, it is clear that severity of attack, under otherwise constant environmental conditions, is a strong function of SO_3 pressure.

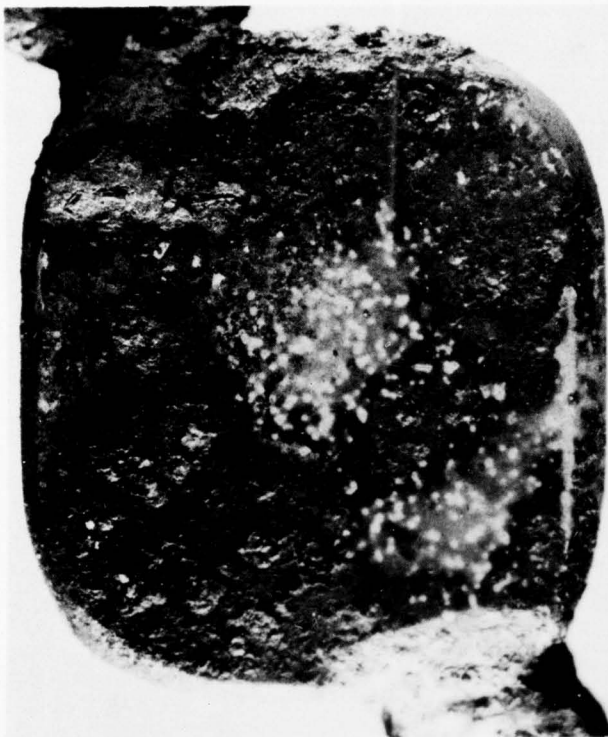
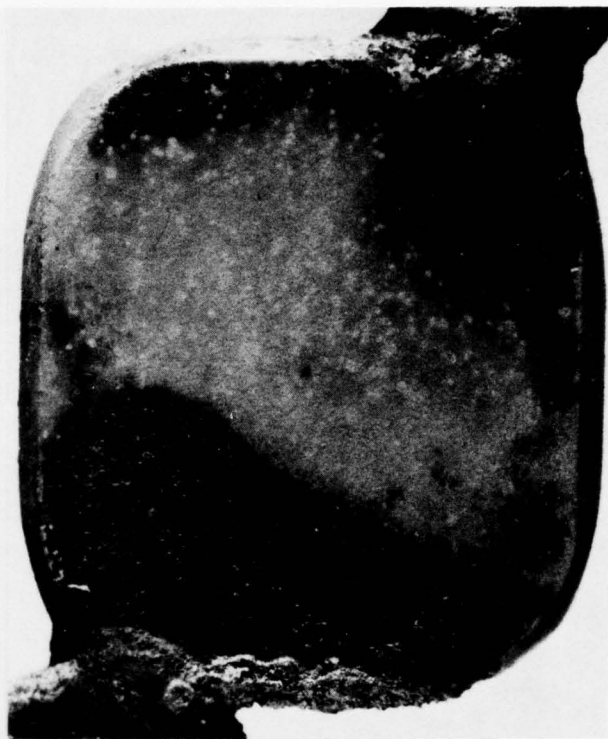
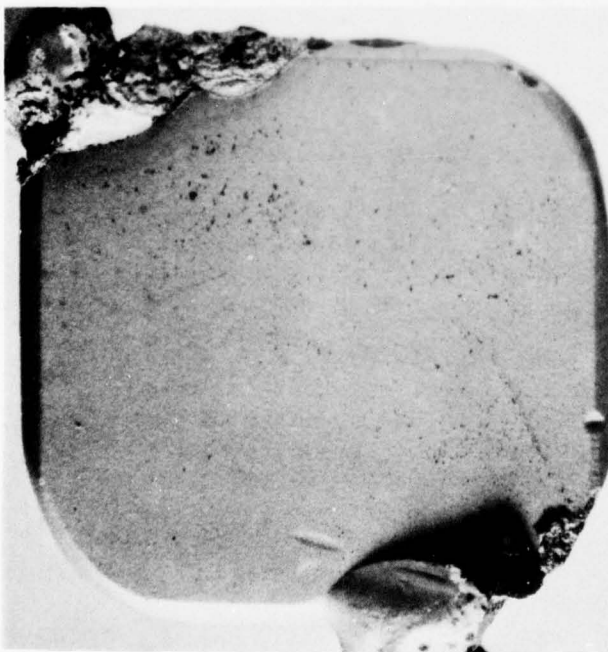
20a. $\text{PSO}_3 = 0.0007 \text{ atm}$

20b. 0.0007 atm , opposite side

20c. $\text{PSO}_3 = 0.0001 \text{ atm}$

Figure 20. Surface condition of PWA 68 CoCrAlY coatings after 100 hours in 899°C hot corrosion test at indicated SO_3 pressures. Opposite side of the 0.0001 atm specimen was also negligibly affected.

In the initial high temperature test at $p_{\text{SO}_3} = 0.0007$ atm, the FWA 68 CoCrAlY was significantly attacked (Figure 20a), although half of one surface was still adherent alumina (Figure 20b) and a very small weight change (about 1 mg/cm² in 100 hours) suggested much less attack than that produced by the same SO_3 pressure at 704°C. At 0.0001 atm, attack of the CoCrAlY was limited to the very small spots of blue spinel shown in Figure 20c; post-test metallography showed no discernable microstructural degradation.

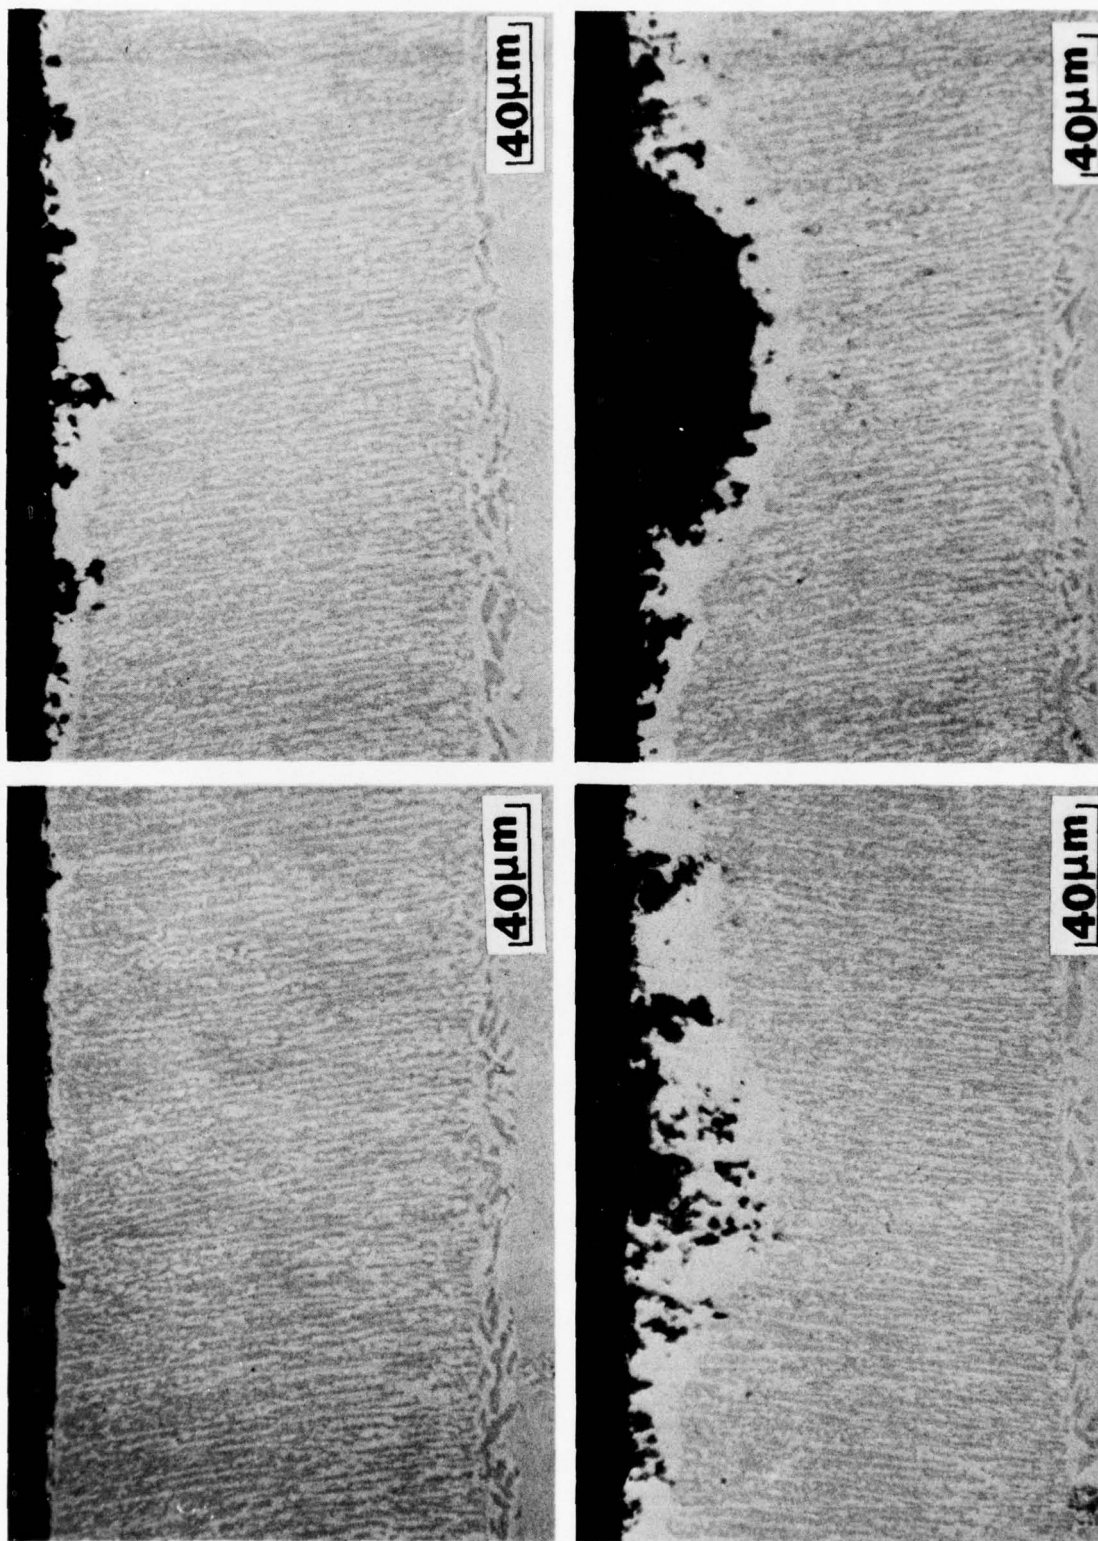
Figure 21. Microstructures of PWA 68 CoCrAlY exposed 100 hours at 899°C and $p_{SO_3} = 0.0007$ atm.

Microstructural features of the 0.0007 atm CoCrAlY specimen are shown in Figures 21 and 22. Optical photomicrographs of randomly selected areas (Figure 21) illustrate the varying severity of attack inferred from the surface condition. SEM examination of a more severely degraded area (Figure 22 and corresponding X-ray maps in Figure 23) shows a highly irregular scale/metal interface and a very prominent β -denuded zone. There is strong concentration of sulfur in the scale as well as sulfur-containing particles in the two-phase $\alpha + \beta$ structure in advance of the β -denuded zone. Line profiles along the path marked in Figure 22 show a slight gradient in Al and Cr content.

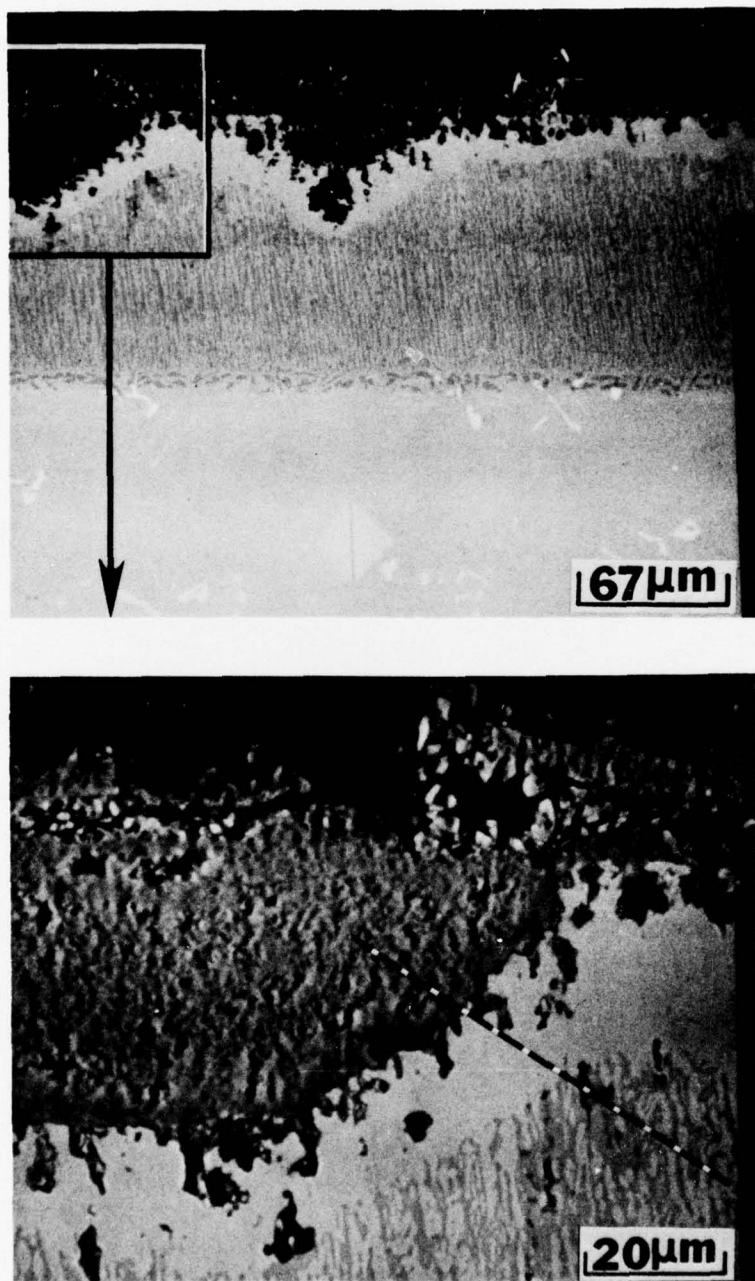
Figure 22. Back scattered electron photomicrographs of heavily corroded area in the CoCrAlY specimen of Fig. 21. X-ray maps in Fig. 23 are the area of the lower photo, but slightly distorted (compressed vertically) due to electronic problems. Dotted line is path of concentration profiles for Al, Cr, S, and O.

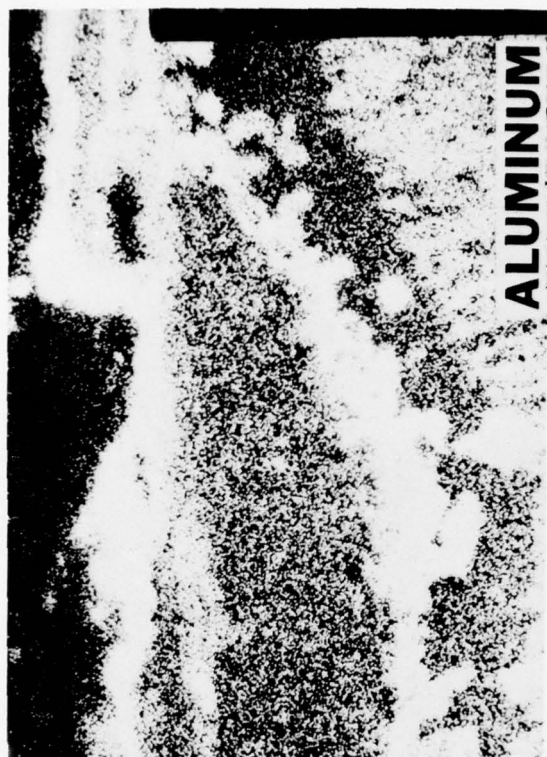
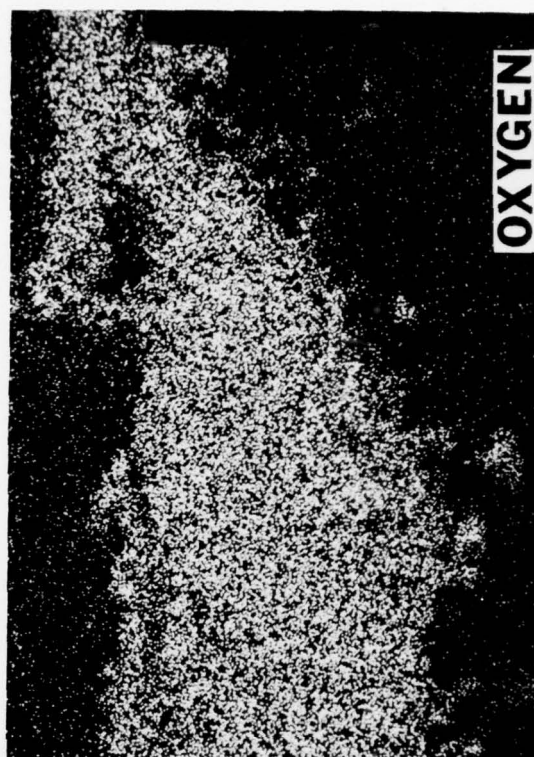
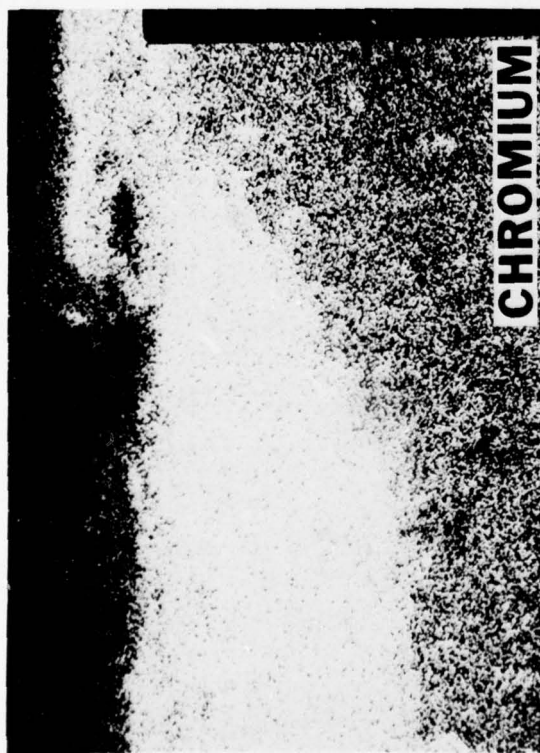
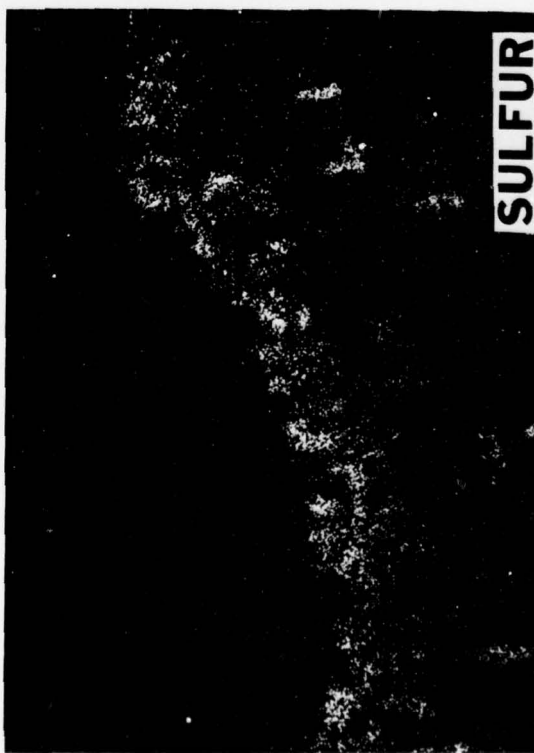
ALUMINUM

OXYGEN

CHROMIUM

SULFUR

Figure 23. X-ray maps showing element distribution characteristic of SO_3 -induced hot corrosion of CoCrAlY coating at 899C.

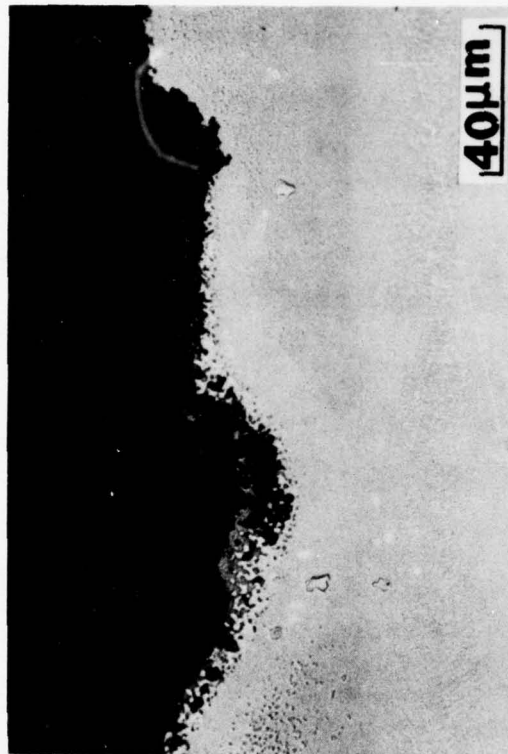
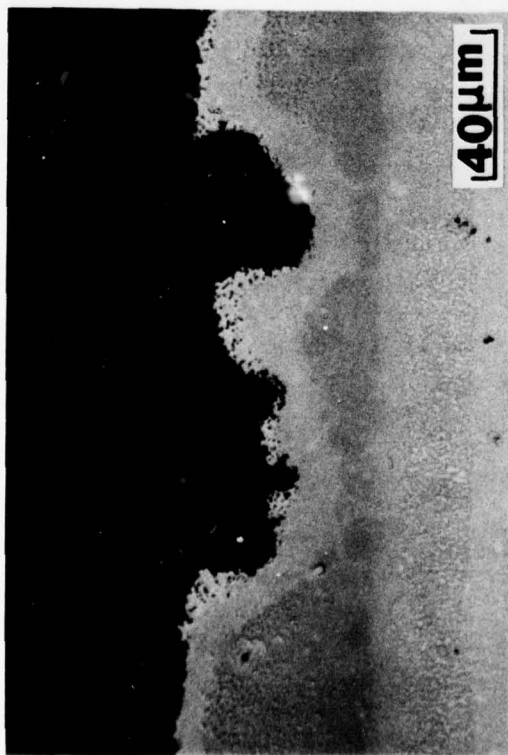
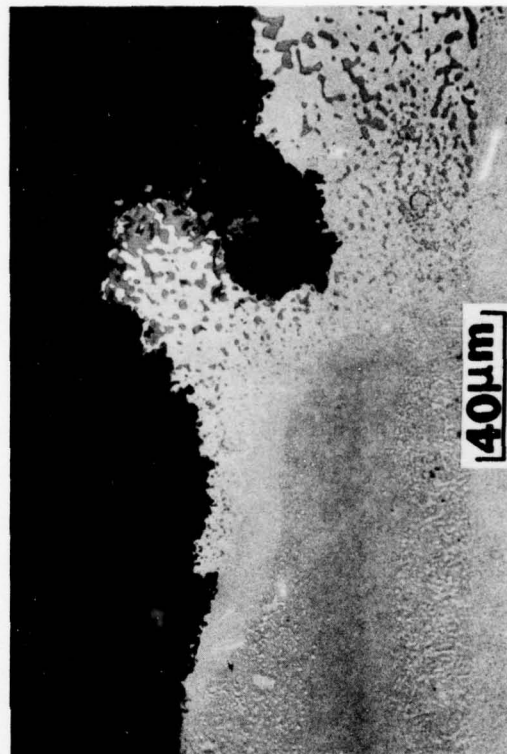
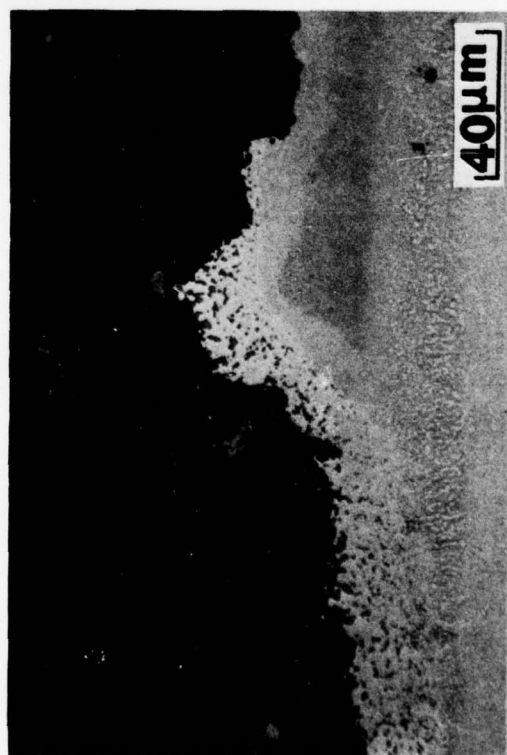
a. 20 hours at $P_{SO_3} = 0.0007$ atm
 b. 20 hours at $P_{SO_3} = 0.0001$ atm
 Figure 24. Degradation and failure of PWA 273 aluminide coating by SO_3 -induced hot corrosion at 899C.

For the uncoated and aluminized alloys tested concurrently with the FWA 68 CoCrAlY, the most striking result was the severe attack of the Ni-base FWA 273 diffusion aluminide. Penetration of the coating at several sites was observed after the initial 20-hour exposure at both SO_3 pressures (Figure 24). Attack of both specimens was highly localized, however, and unaffected microstructure still exhibited the characteristic purple color of as-processed β -NiAl. Copious sulfide precipitation associated with the localized attack may reflect cut-edge degradation, although results presented in the following paragraph show that the uncoated alloy is susceptible to gross sulfidation under these environmental conditions.

The aluminide coating on IN 792 was resistant to SO_3 effects at 704°C; although significant weight losses and surface degradation were observed, the coating was not penetrated even by 100 hours at 0.004 and 0.0007 atm (Figure 10, 12). Conversely, exposure to SO_3 at 899°C caused rapid sulfidation and penetration of the coating after only 20 hours (Figure 24).

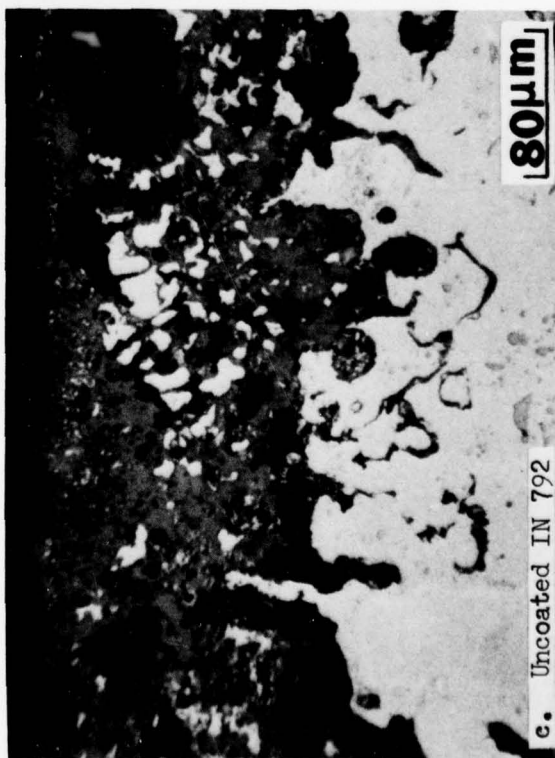
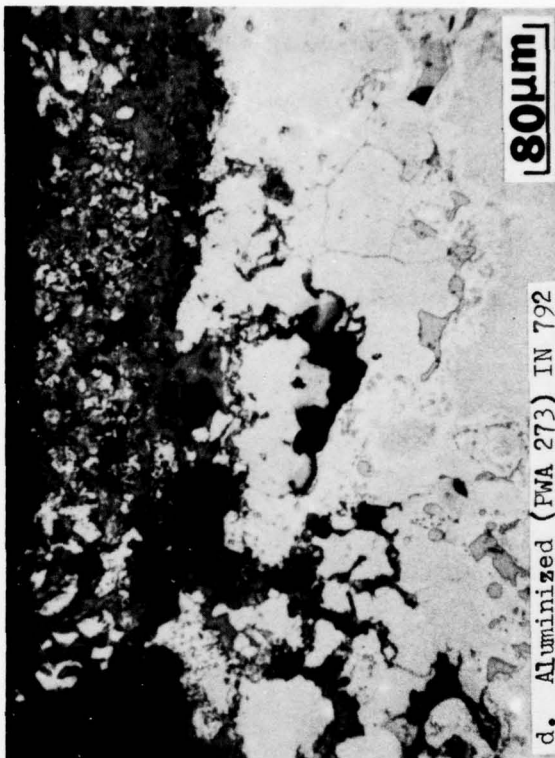
Figure 25. Uncoated and aluminized alloys exposed 100 hours (except 80 hours for aluminized IN 792) at 899C and $p_{SO_3} = 0.0007$ atm. Note different magnification of Co-base and Ni-base alloys.

Microstructures of the uncoated and aluminized alloys exposed to NaCl and SO₃ at 899°C are presented in Figure 40; comparison with the structures developed at the same temperature with SO₃ alone (Figure 25) shows substantially less attack in the experiment with NaCl vapor. The Co-base system (uncoated and aluminized Mar-M509) shows no features attributable to NaCl, while the concurrently tested Ni-base system apparently exhibits the type of internal oxidation characteristic of chlorides.

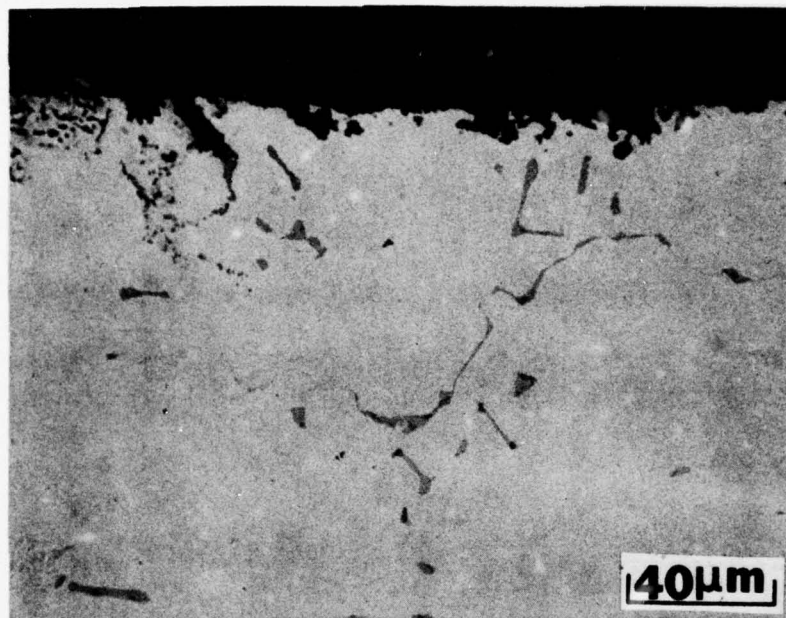
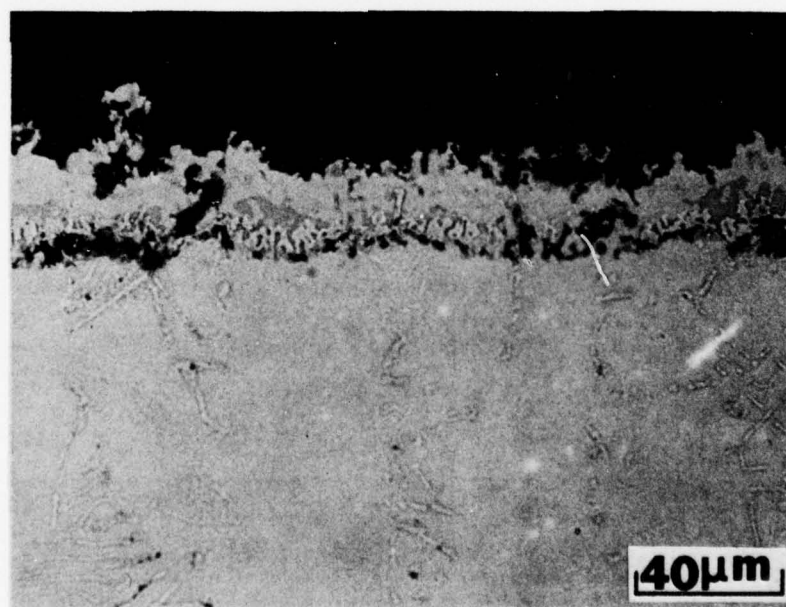
a. Uncoated

b. Aluminized

Figure 26. Typical microstructures and depth of attack of uncoated and aluminized Mar-M509 exposed 100 hours at 899C and $p_{SO_3} = 0.0001$ atm.

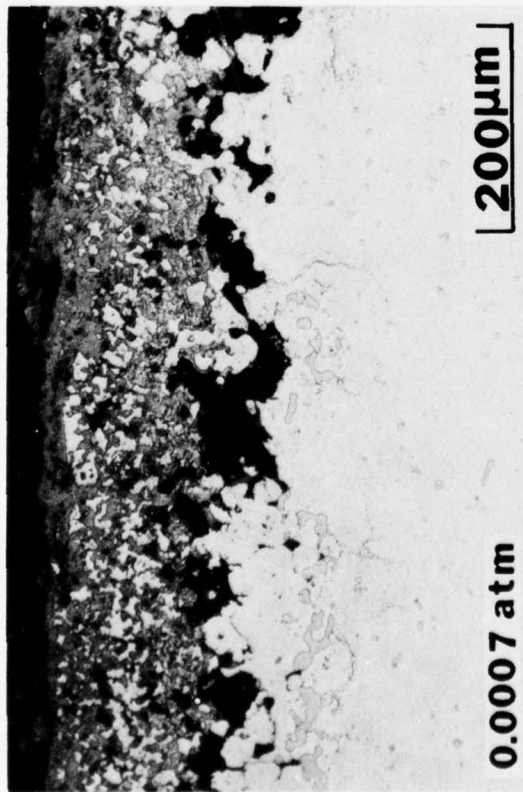
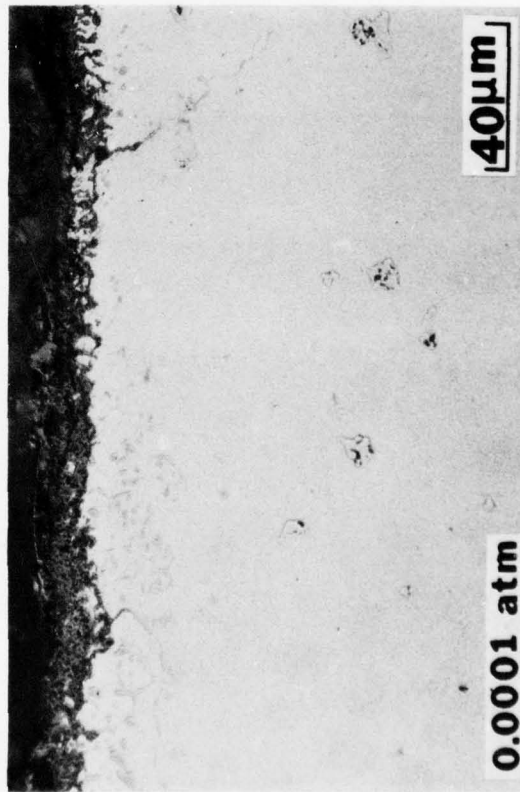
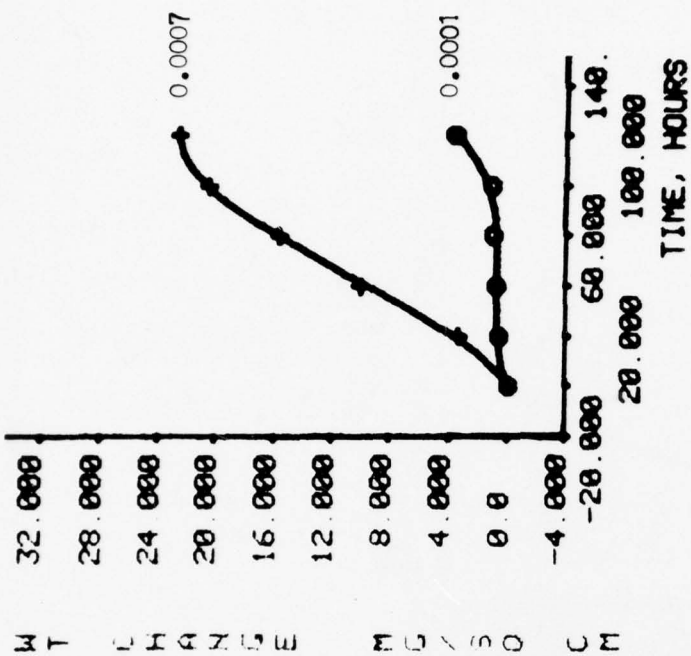
Figure 27. Effect of SO_2 pressure on 899C hot corrosion of uncoated IN 792, as shown by depth of attack and weight change data for 100-hour exposure at 0.0007 and 0.0001 atm. Note different magnification of the two photomicrographs.

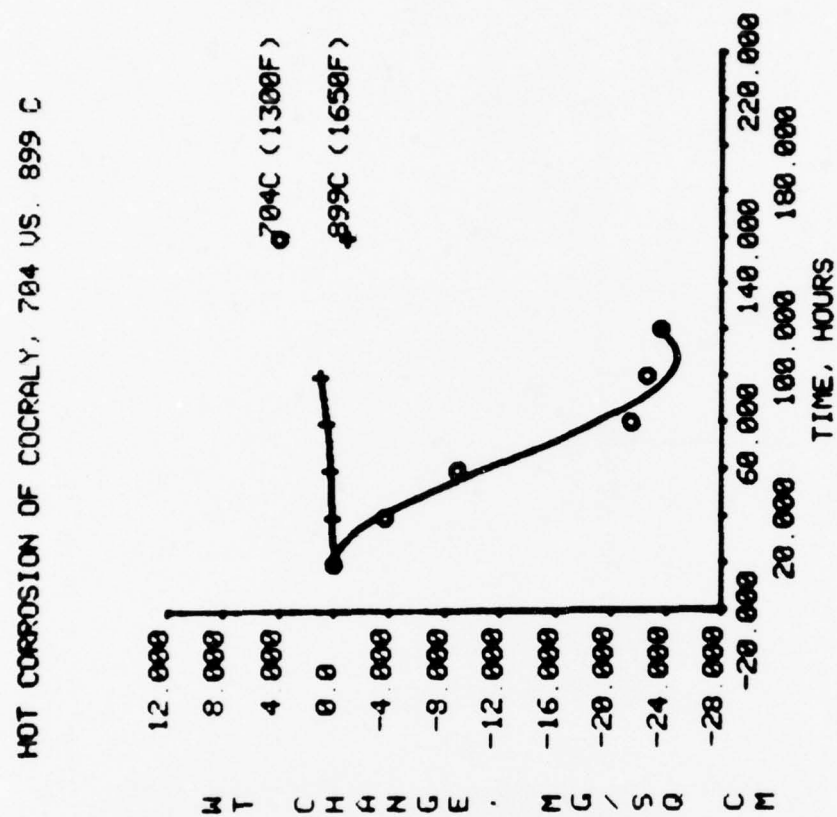
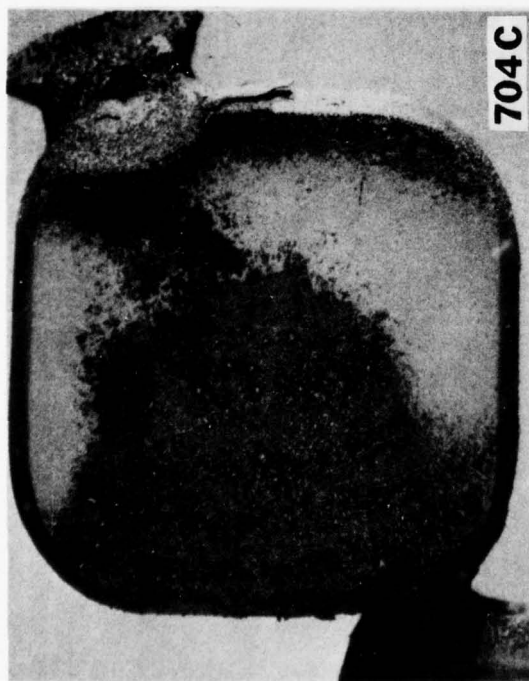
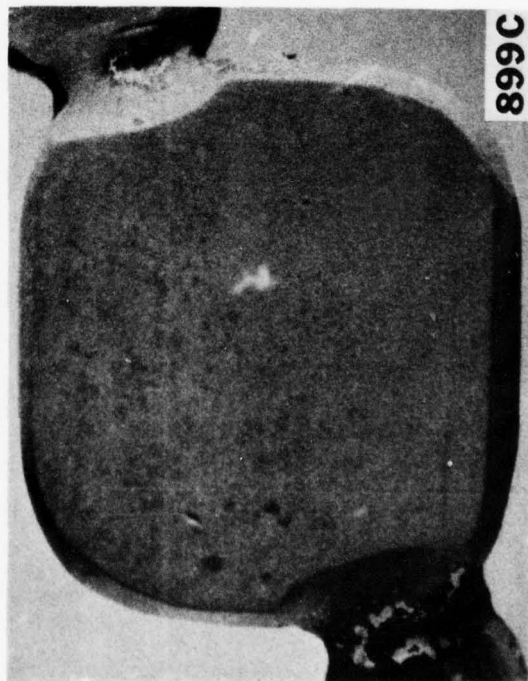
Figure 28. Effect of temperature on severity of attack of FWA 68 CoCrAlY coating at fixed SO_3 pressure of 0.0007 atm, as shown by surface condition after 20 hours and weight change data for 100-hour cyclic exposure.

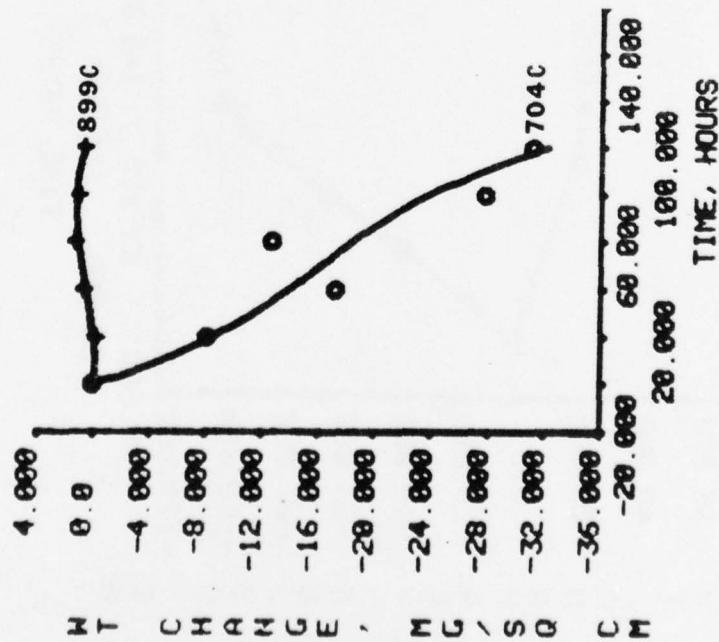
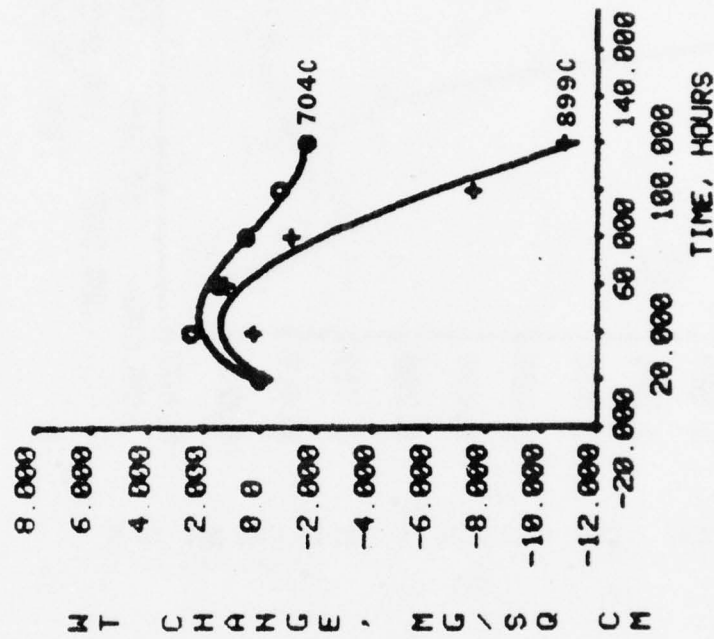
a. uncoated

b. aluminized

Figure 29. Weight change data showing effect of temperature on severity of attack of uncoated and aluminized Mar-M509 at fixed SO_3 pressure of 0.0007 atm.

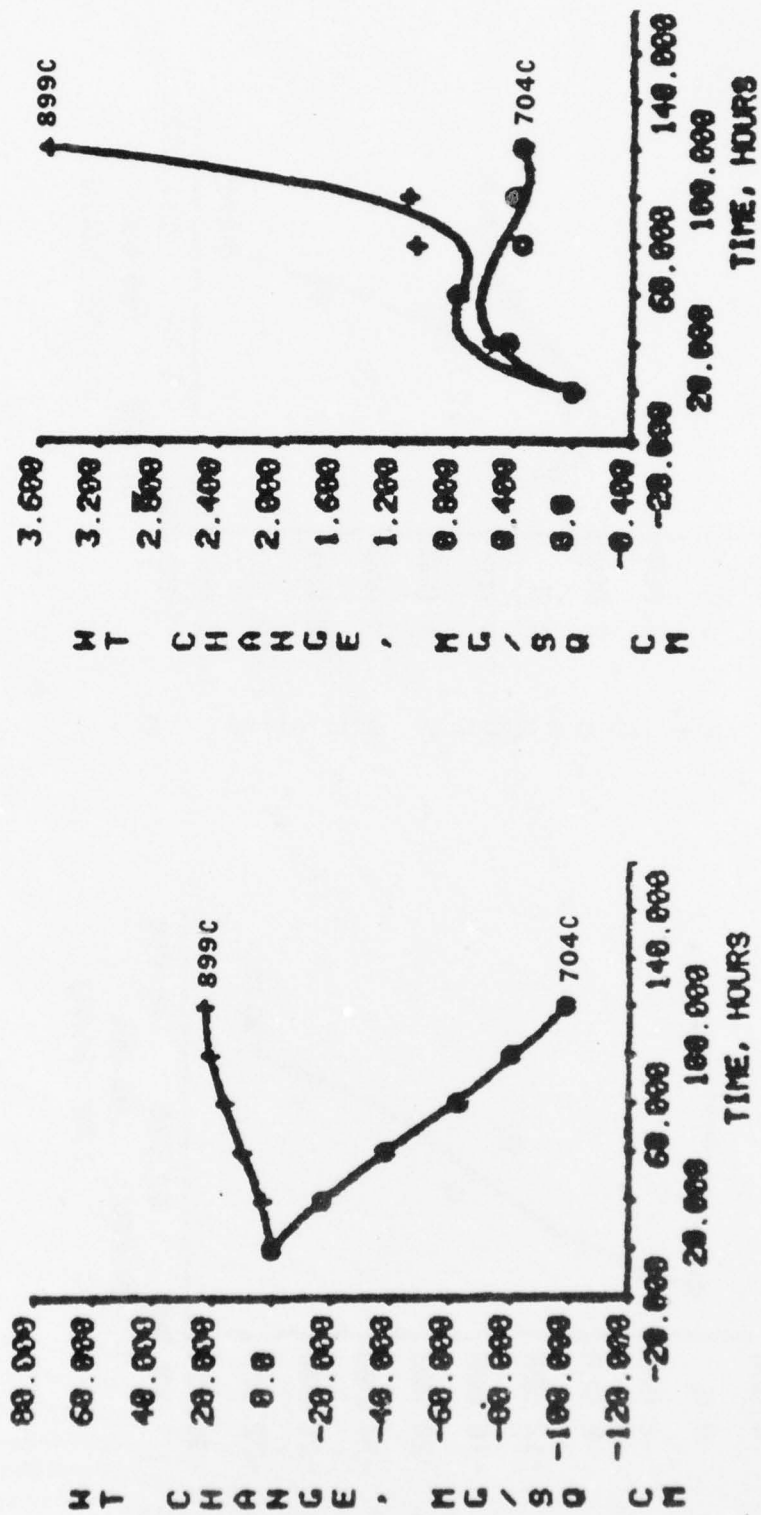
Figure 30. Effects of temperature and SO_3 pressure on severity of attack of uncoated IN 792, as shown by weight change data at fixed SO_3 pressure (30a and 30b respectively) and relative magnitude of $\Delta M/A$ values at 0.0007 versus 0.0001 atm.

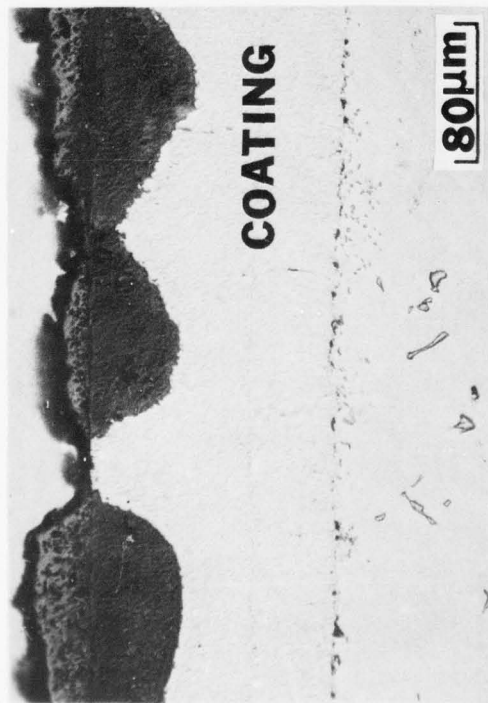
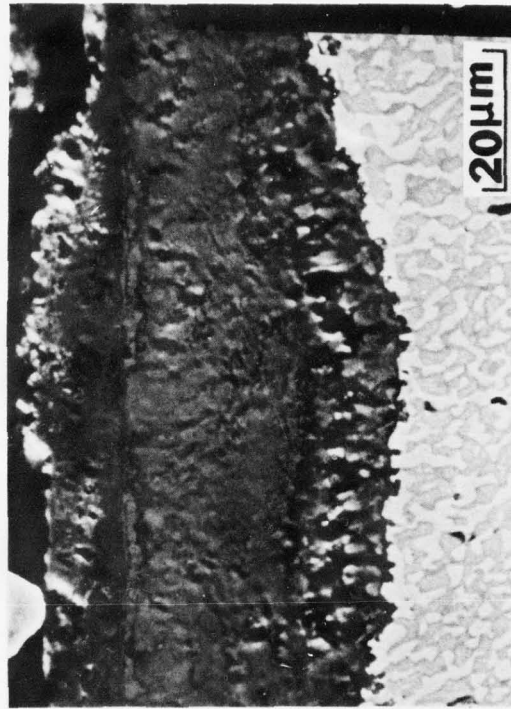
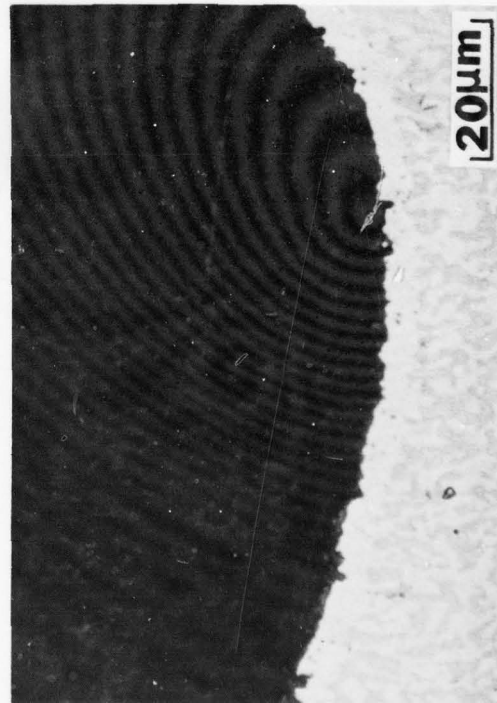
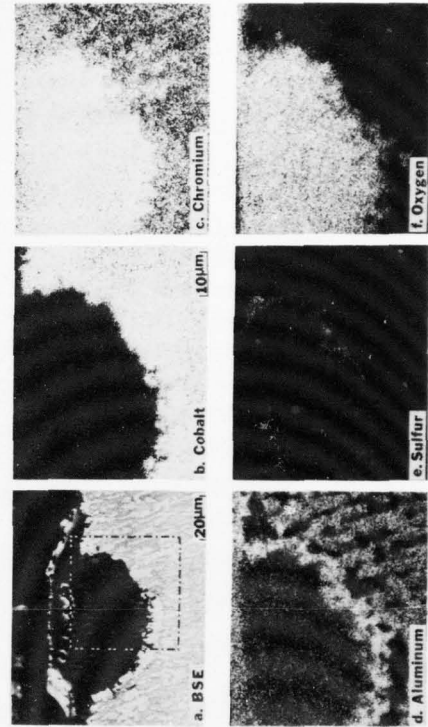
Figure 31. Typical degradation microstructures observed in CoCrAlY-coated turbine hardware from GTV Asiafreighter after approximately 4200 hours service.

Based on this reasoning and the information summarized in the bullet items just listed, it is strongly believed that hot corrosion of the type illustrated in Figure 31 is due to low temperature (i.e. about 750°C or below) exposure to condensed Na_2SO_4 salt and SO_3 in the combustion gases.
